# Optical Diagnostics on Mock-up/SS Primary

## Small leak on SS primary

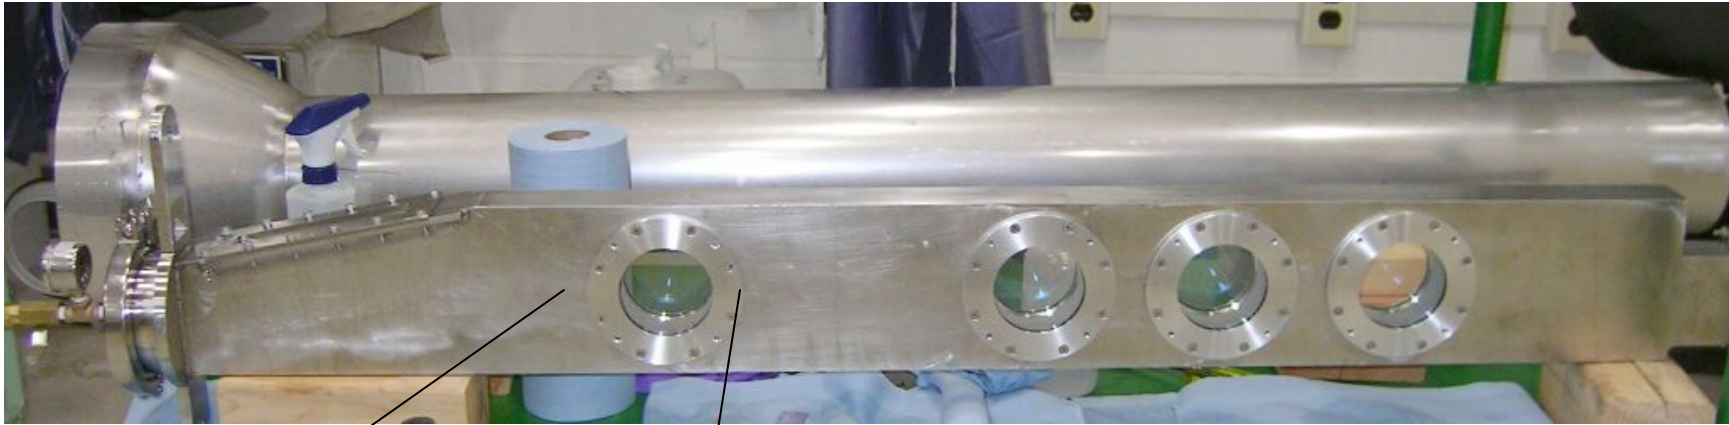
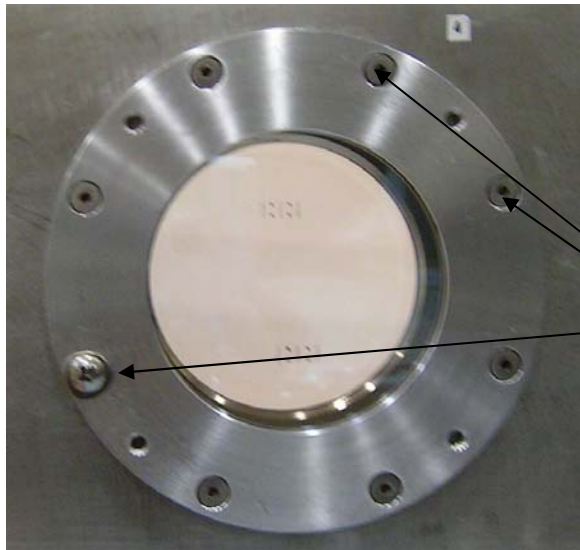
10/06/06 - large leak detected, all gaskets are not good

10/10/06 - new gaskets installed, small leak detected, in 17 hrs pressure drop from 21 to 8 psi, fixed viewport #4 gasket.

10/11/06 – small leak in 21 hrs pressure drops from 21 to 19 psi leak rate of  $\sim 1.4$  mTorr/sec

10/12/06 - Leak check using Metheson 8850 flammable gas sniffer, 5 ppm sensitivity, 15 psi of Ar/Methane (90%/10%) several tap holes aren't deep enough on viewport #4, shorten a few screws and tighten the viewport.

10/13/06: No leak detected, 21 psi holds for over 17 hrs
